EFFECTS OF ABNORMAL CONDITIONS ON ACCURACY OF ORIFICE MEASUREMENT

Class # 1100

Thomas B. Morrow, P.E.
Engineering Consultant
8327 Chivalry St.
San Antonio, TX 78254 USA

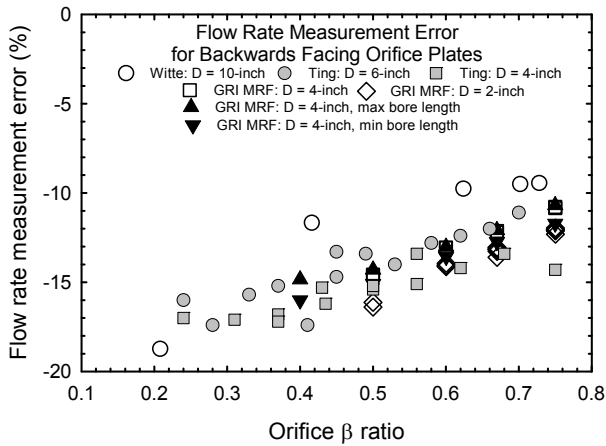
Fig. 1 Measurement error caused by installing orifice plate backward in orifice fitting or flange.

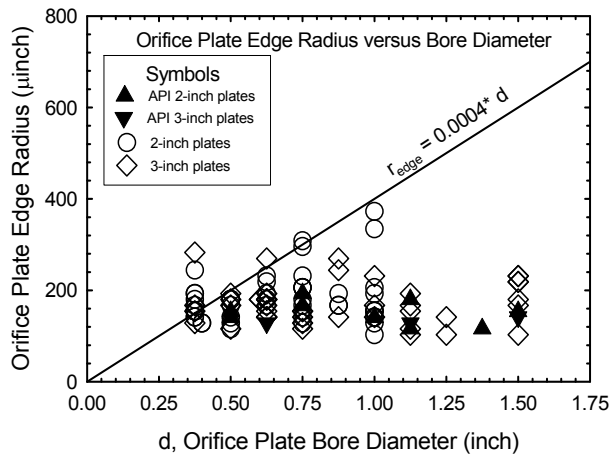
Fig. 3 Measured values of sharp edge radius for 2-inch and 3-inch orifice plates.

Edge sharpness measurements using the lead foil method were made on over 100 2-inch and 3-inch diameter orifice plates for the GRI MRF orifice meter installation effects program. The results of the tests are shown in Figure 3 as orifice plate edge radius versus orifice plate bore diameter.

Spencer's correlation for the maximum allowable edge radius as a function of bore diameter is shown as a straight line in Figure 3.

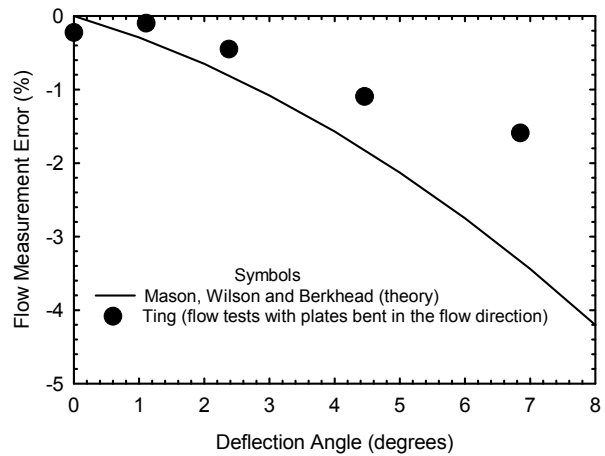
Fig. 5 Measurement error for 4-inch diameter bent plate with $\beta = 0.50$

Ting showed experimental results obtained with 4-inch and 6-inch orifice plates that were bent by a press up to 10° in the flow direction. Figure 5 shows the measurement error for a 4-inch diameter $\beta = 0.50$ plate as a function of the orifice plate deflection angle. The measured values are compared with predictions from the elastic deformation model developed by Mason et al. While the trends are similar, Mason's theory over-predicts the magnitude of the measurement error for a given deflection angle. It is also possible that the deflection angle may vary across the face of the plate from the circumference to the bore.

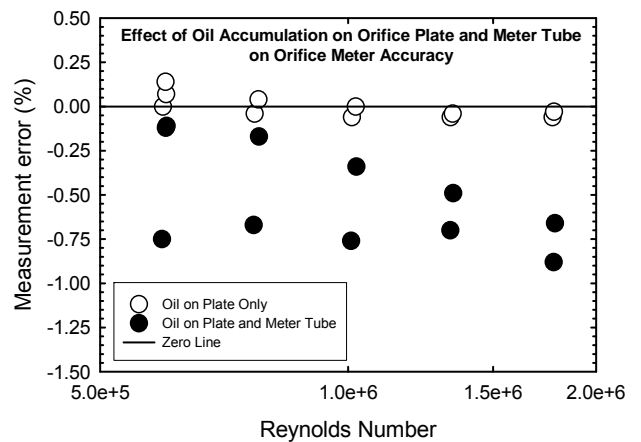
Fig 6 Effect of oil film on orifice plate and on orifice plate and meter tube.

Figure 6 shows one set of test results for the 6-inch meter tube and $\beta = 0.67$. Baseline C_d values have been subtracted from the wet plate and wet plate and wet meter tube results, and the results plotted as metering error versus pipe Reynolds number.

Figure 6 shows that oil in the upstream section of the meter tube produced a significant measurement error. The magnitude of the error decreased with time, probably as oil was swept away from the meter tube surface. Johansen observed that the error could be due to a flow of oil from the tube to the plate, or simply due to the effect of oil in modifying the surface roughness of the meter tube. Waviness of an oil coating on the inside of a pipe effectively increases the surface roughness of the pipe. Increasing the pipe wall surface roughness is known
