ADVANCED GAS ULTRASONIC METER DIAGNOSTICS

ABSTRACT

This paper discusses advanced diagnostic features of gas ultrasonic meters (USM), and how capabilities built into today's electronics can identify problems that may have gone undetected in the past. It primarily discusses fiscal-quality, multi-path USMs and does not cover issues that may be different with non-fiscal meters as they are often single path designs. Although USMs basically work the same, the diagnostics for each manufacturer does vary. All brands provide basic features as discussed in AGA 9 [Ref 1]. However, some provide more advanced features that can be used to help identify issues such as blocked flow conditioners and gas compositional errors. This paper focuses on the Westinghouse and British Gas configurations (both being chordal designs) and the information presented here may or may not be applicable to other path designs.

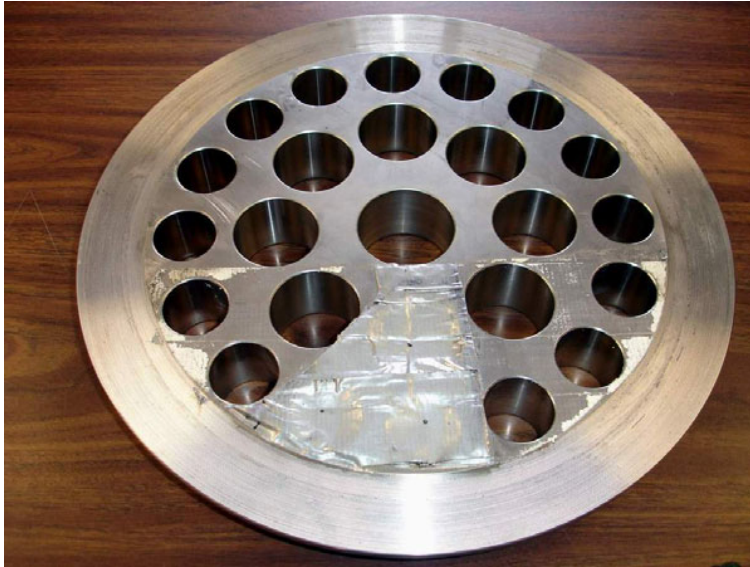
Figure 10 – 3 Holes Blocked Flow Conditioner

In the past many have believed that looking at the Profile Factor alone would be a good indication if any contamination or flow conditioner blockage existed. This may not always be true. Figure 10 shows a picture of a flow conditioner with 3 holes blocked at the bottom.

In this test the three blocked holes in the flow conditioner were located at the bottom of the meter run. This is the same 12-inch meter and testing as discussed with the 40% blockage. Figure 11 shows a graph of the Path Ratios during this test with the 3 blocked holes located at the bottom of the meter piping.

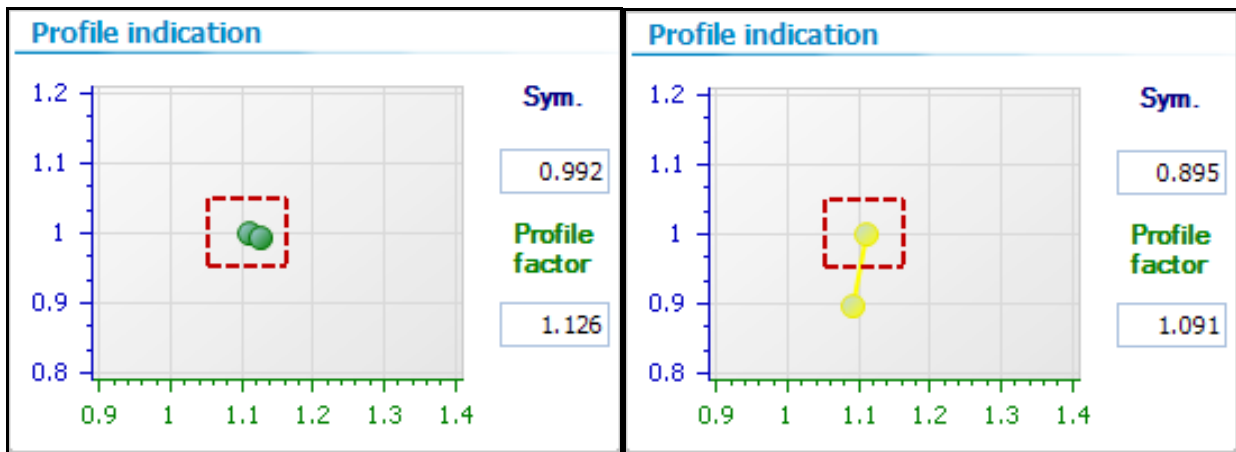
Figure 18 – Normal Profile Factor and Symmetry Figure 19 – Abnormal Profile Factor and Symmetry

The Profile Indication box is really a summary of both the Profile Factor and Symmetry. The dot in the middle of the box is established when commissioning the meter and is the average value when first started up. The second dot is the current, or live, value of the Profile Factor value (represented by the X axis) and the Symmetry value (represented by the Y axis). When either of these values causes a change of more than 5% (an adjustable value but just a baseline for this example), then the line turns yellow indicating there is a significant change. Figure 38 shows a close-up of a normal value, and Figure 39 show a problem.

Figure 18 shows a dot just to the right of the centered one (which is configured in the meter) and it represents the current reading of both Profile Factor and Symmetry. These values are shown to the right of the graph.

When a problem occurs that causes a shift in either Profile Factor or Symmetry, by more than the programmed limit in the meter (shown here as 5%), then the dot will move outside of the box and turns yellow. Such is the case for Figure 19 where we see the Symmetry is 0.895, or more than 10% from normal (1.00 being normal). Thus the technician can very easily see there is a problem with the profile.

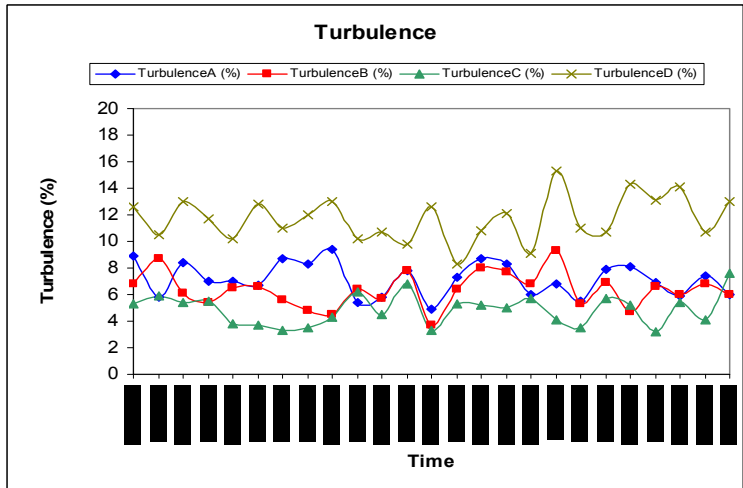
Figure 23 – 12-inch Meter With High Turbulence

Figure 23 shows all the turbulence values are significantly above the normal values that are 3-4%. Since all Turbulences are high, there must be something blocking the flow conditioner. The following picture shows the issue causing the distorted flow profile and high Turbulence.

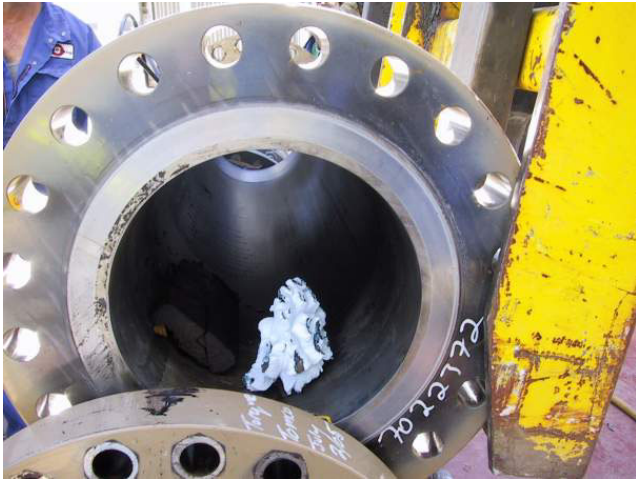
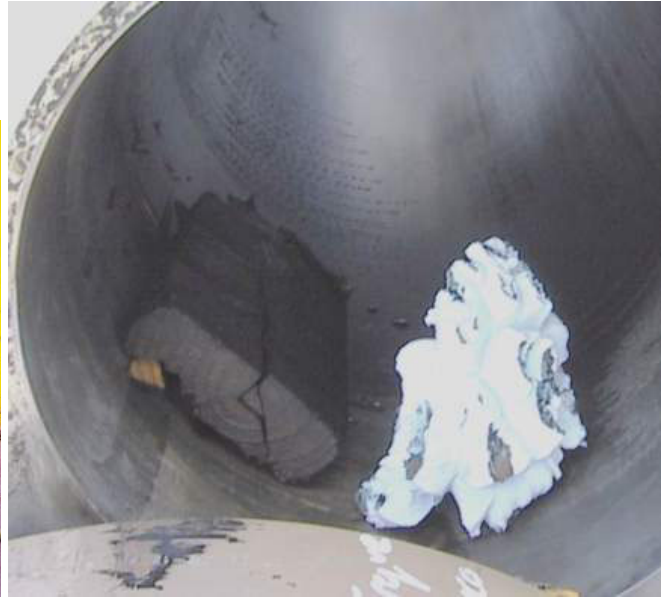
Figures 24 and 25 show the debris that was in front of the flow conditioner. These two items caused the distorted profile and high turbulence. Figure 26 shows the Path Ratios after the debris is removed, and Figure 27 shows the Turbulence values that have now returned to normal.

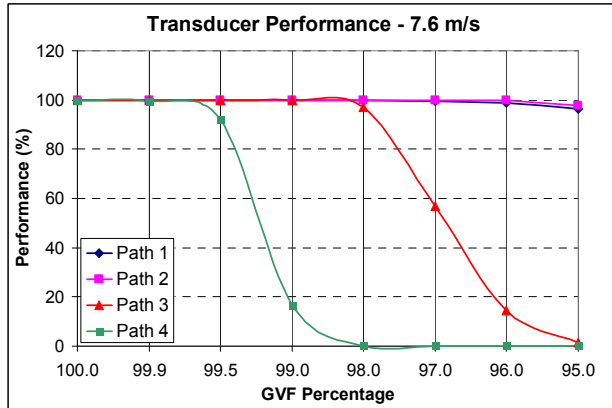
Figure 28 – 4-inch Transducer Performance

There are 4 basic diagnostic parameters that can be used to identify when liquids are present. They are Performance, Path Ratios, path SOS and Turbulence values. These addressed in more detail in a previously published paper [Ref 6]. The following four graphs represents data from a 4-inch, 4-path Westinghouse design

meter when it is subjected to increasing amounts of liquid. The baseline is 100% Gas Volume Fraction (GVF), and then liquid is systematically increased at the lab under controlled conditions until the GVF is 95% (5% Liquid Volume Fraction).

Figure 28 shows Path 4 performance begins to decrease when the GVF is around 99.5%, and as the liquid is increased, eventually it fails around 98%. Path 3 begins being affected at 98% and at the highest tested liquid loading of 95% GVF, it also fails. Just looking at this one diagnostic doesn't clearly show what the problem is since this could be the result of contamination or other affects. By looking at Figure 29 it is apparent the Path Ratios are changing at the same time. Path 4 begins going slower when compared to Path 1, and the same is true for Path 3 compared to Path 2.

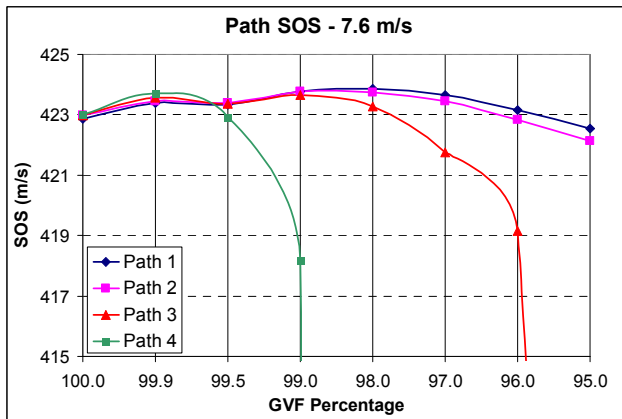
Figure 30 – 4-inch SOS Readings

Figure 30 shows something different is happening with per-path SOS. The SOS on Path 4 is now going slower relative to the other three paths. This might be the reverse of "common wisdom" since the SOS in liquid is higher than gas, and at this point probably mostly at the bottom of the meter. Now there are three distinctly different looking graphs of diagnostics telling us there is a problem. When these are combined with the final diagnostic, Turbulence, it is clear liquids are present. Figure 31 shows the sensitivity of Path 4 Turbulence for even the slightest amount of liquids. The important part of the Turbulence graph is that only Path 4 turbulence has increased significantly compared to all the others (which remain relatively normal until very high levels of liquid are present). This is further confirmation that liquids are present.
